GENERAL DOCUMENT

MRL-GD-0004

A REVIEW OF THE IMPROVEMENTS TO ARMOURED-VEHICLE TRACKS FOR THE AUSTRALIAN ARMY

T.W. Rea

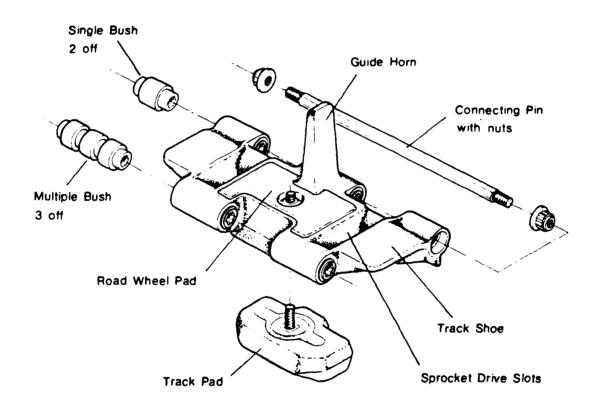
FIG. 1 M113 A1 APC - Track Shoe

In the M113 single pin track the connecting pin is supported along its full length by the steel tubes moulded into the rubber bushes and protected by the interlocking lugs of the track shoe. While the bushes remain intact no direct loading occurs on the metal pin, the drive load from the sprocket being applied to the body of the track shoe (Fig. 1).

The breakdown of the M113 track has been associated with the premature failure of the rubber bushes. Although isolated cases of broken and thrown track have been reported, it has commonly been rubber bush failures which led to metal-to-metal contact of the pin and track shoe and eventual failure of the metal shoe material and breaking of the connection. Part of the problem has been traced back to the quality control of the rubber bushes during manufacture, and these procedures have been revised by the Army Quality Assurance authorities in collaboration with MRL, in work outside the scope of this report.

- The problem of the short life of the rubber pin bushes in the Mil3 track has been investigated at MRL (Organic Chemistry Division) and a new rubber formulation for bushings has been developed. This formulation is currently under trial on both the Mil3 track and on Leopard track. Laboratory tests at MRL have indicated that bushings in the new formulation are superior to the present bushes being supplied to SAF for Mil3 track.
- (c) The use of a cast M113 track shoe to replace the present forged item, with a cost saving estimated at 60%, has been developed at SAF with the collaboration of MRL [4]. Two types of casting have been investigated, investment casting by SAF and sand casting by private industry.

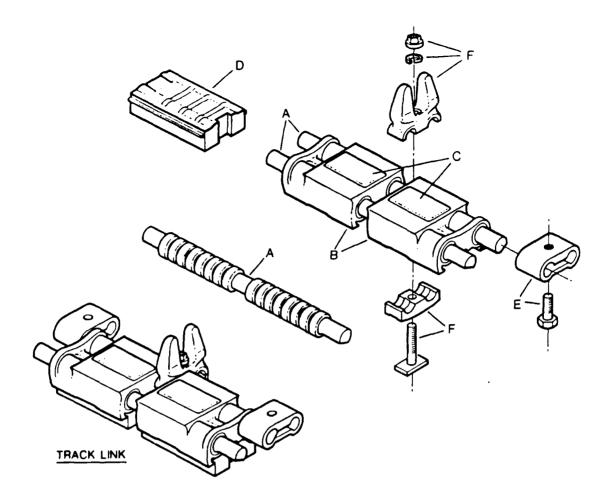
FIG. 2 Leopard Tank - Track Link Assembly

In the Leopard MBT double pin track track pins are supported by rubber bushes pressed into the two link bodies, however there are unsupported areas where the 'end connectors' and 'centre guide' are attached (Fig. 2). In addition the drive loading is applied by the sprocket to the end connectors fixed to the unsupported ends of the pins, and the centre guide transmits both the drive load and lateral forces directly to the unsupported centre of the pin.

In service severe bending loads are imposed on track pins at the unsupported area between the link bodies and connecting links, and fatigue cracking of the pins initiate at sites where the abrasive action of the entrapped soils and debris erode the soft surface of the pin. The fatigue crack in the centre area of the pin had four possible locations, on the upper and lower surface of the pin each side of the centre guide; these are locations where the maximum bending stress would be applied by the passage of the road wheels across the track link. The cracks at the ends of the pins were confined to one area, on the inside surface of the pin, adjacent to the flats and level with the end connector where the maximum bending stress would be applied by the action of the sprocket wheel (Fig. 2). The cracks in the

centre area were from a single initiation point [1], however multicracking would occur in the area at the ends of the pin when the end connector moved position during service.

Occasional pin failures still occur on the induction hardened pin, mostly originating at the run-out radius of the flat at the ends of the pin. Microscopic examination of failed pins has revealed that the induction hardening treatment had failed to cover a localized area across the run-out radius. Fatigue testing in the laboratory [5] confirmed this cracking behaviour, attributed to the coincidence of a geometric stress concentration with a softer surface which had inadequate fatigue resistance. Using a mechanical surface treatment by peening to induce residual compressive stresses, it was found possible to "heal" this weakness to an extent so that on further fatigue testing the cracks would initiate at other sites on the pin. It was also observed during this fatigue testing that propagation of the crack to failure was faster in these pins than in the original soft pins.

As a result of investigating the fatigue cracking of the track pin, MRL recommended [1] that orders placed on Germany for replacement link assemblies should specify induction surface hardening of the original pins, as this treatment would enhance the static and fatigue strength, and increase the resistance to erosion of the track pin. (These original pins, without hardened surfaces, are referred to as "soft pins" in this report). The MEA/MRL trials [3] on track fitted with the surface hardened pins were carried out at the Armoured Training Centre, using the Leopard high-usage training vehicles. A track life of approximately 9000 km was achieved before the track was sufficiently worn and deteriorated to require removal from the tank. On examination of the track pin only slight erosion on the surface was noted and no cracking initiating from these sites was detected [3].

It has been demonstrated that proper care must be taken in both the tensioning and retensioning of the bolts securing the end connector and centre guide connector to the track pins. Unless the threads are thoroughly cleaned and well lubricated the correct tension required to secure the connectors to the links cannot be achieved. If this care is not applied it can lead to accelerated failure of the rubber bushes, pin failure, link body migration and in extreme cases loss of track from the vehicle. The Army has accepted these findings [5] and MRL has collaborated with MEA in advising on these procedures for inclusion in the appropriate EME Instructions.

(a) The problem of the "soft" areas found in the imported Leopard track induction hardened pins has been addressed in the SAF Australian made pins. One such modification which achieved some degree of hardening on the radius has been fatigue tested and evaluated at MRL [12]. This modification consisted of slowing down the rate of induction traverse across the critical radius, to achieve greater penetration into the radius region.
